## Mock Inspection Report

3137 North Frederic Street, Burbank, CA, USA

Aug 27, 2025

This is a mock inspection report to demonstrate that the inspector has performed an inspection according to the [InterNACHI® Standards of Practice](#).

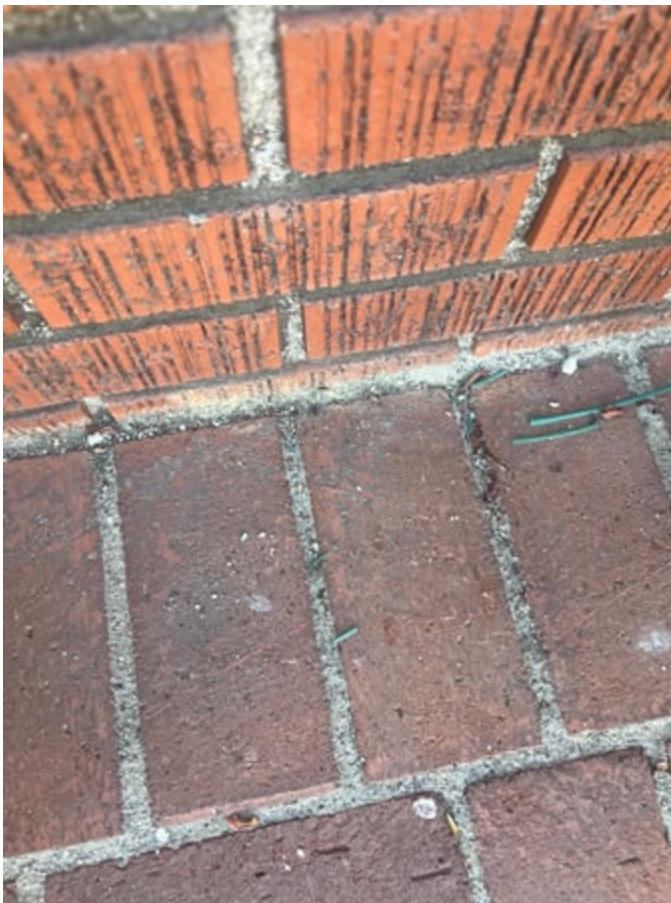
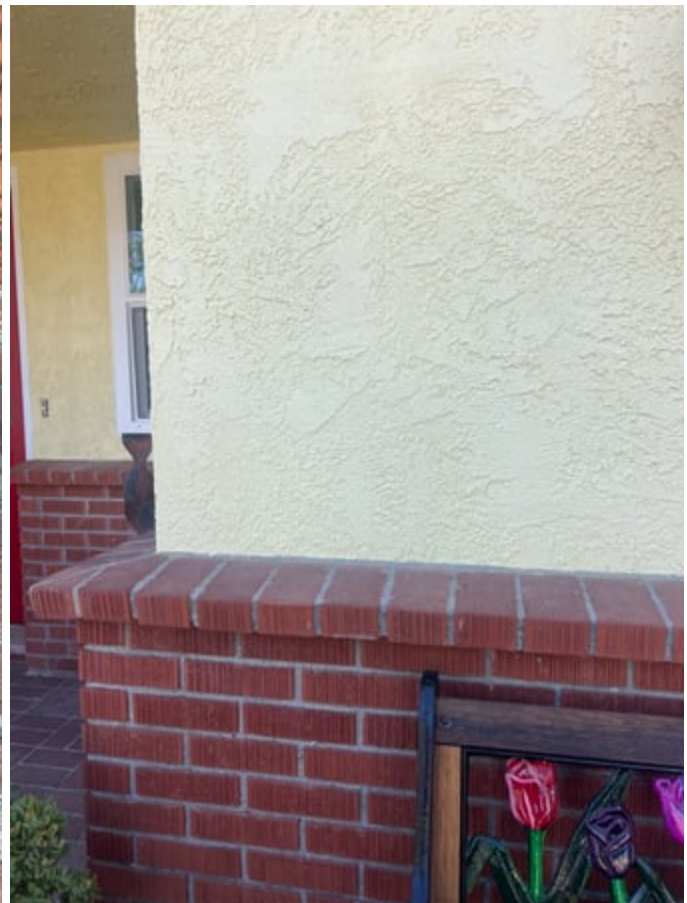
- Observed Condition: Mortar joint deterioration at brick veneer.
- Implication: May allow moisture entry ☒ possible water damage & spalling.
- Recommendation: Masonry contractor to repoint/repair joints.

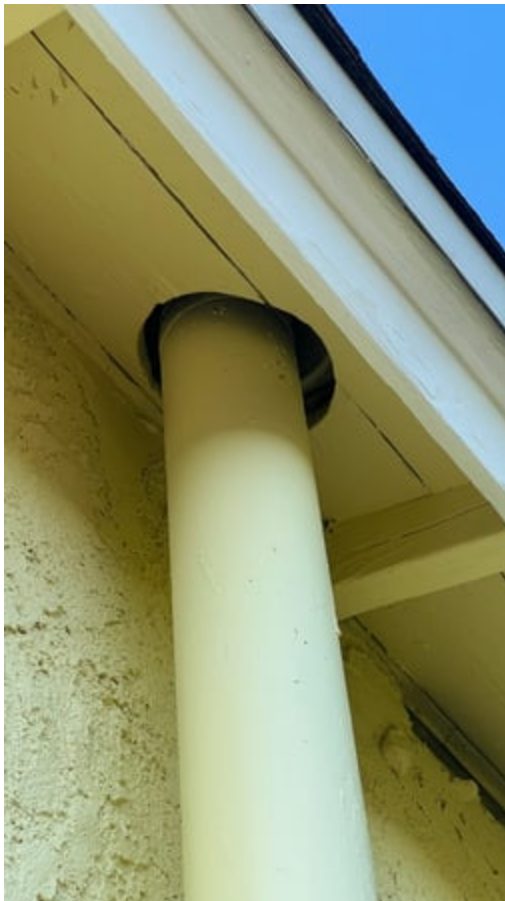
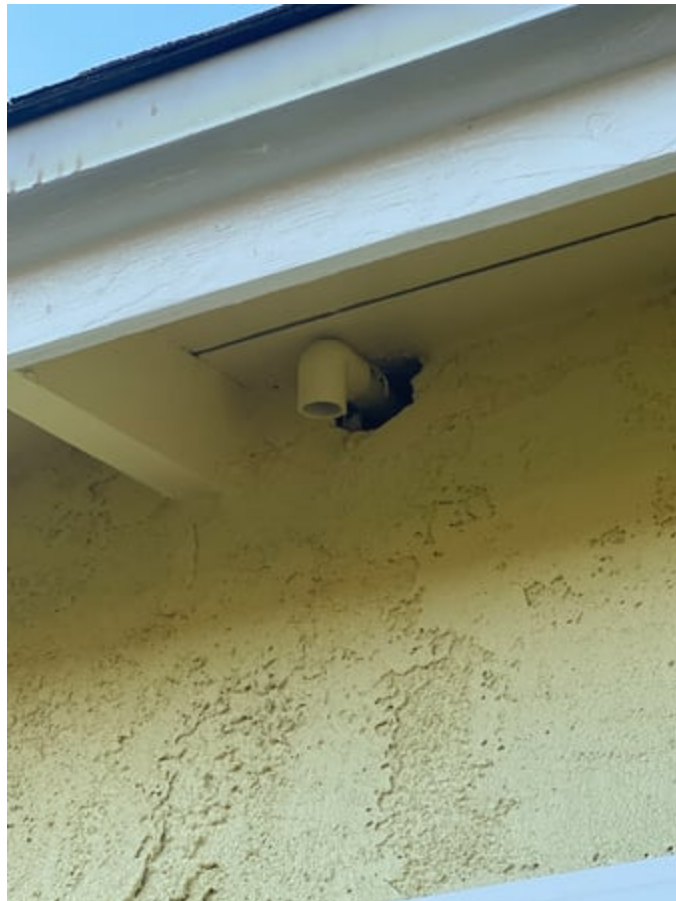
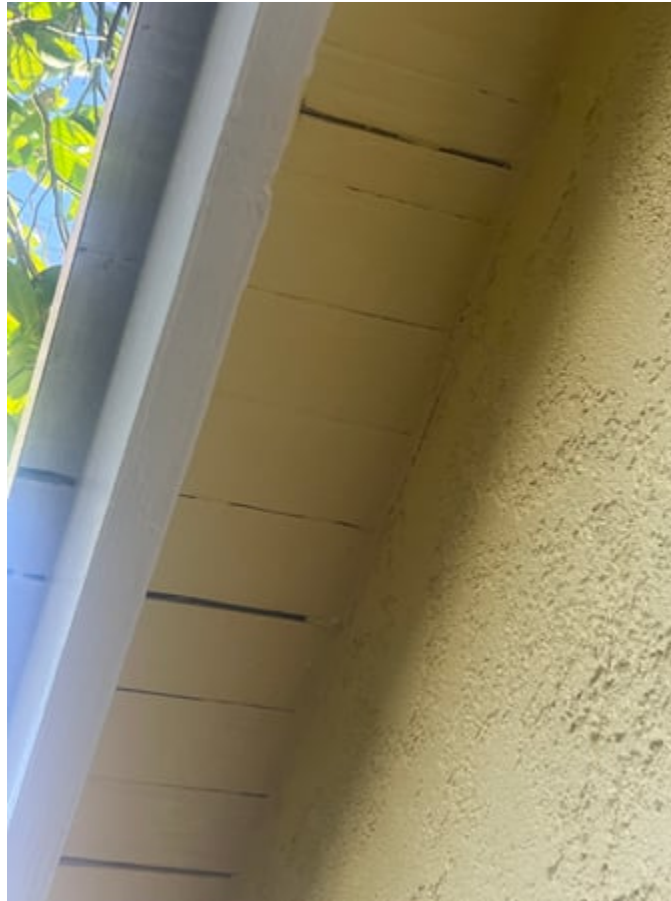
I inspected the eaves, soffit, and fascia areas. Several penetrations were observed where pipes extend through the soffit (above the water heater and at the PVC vent). These penetrations were not properly sealed, which could allow pest entry or moisture intrusion. Additionally, gaps were observed in the soffit panel joints. I recommend sealing all penetrations and repairing/closing gaps to maintain a weather-tight and pest-resistant building envelope. A qualified contractor should perform these repairs

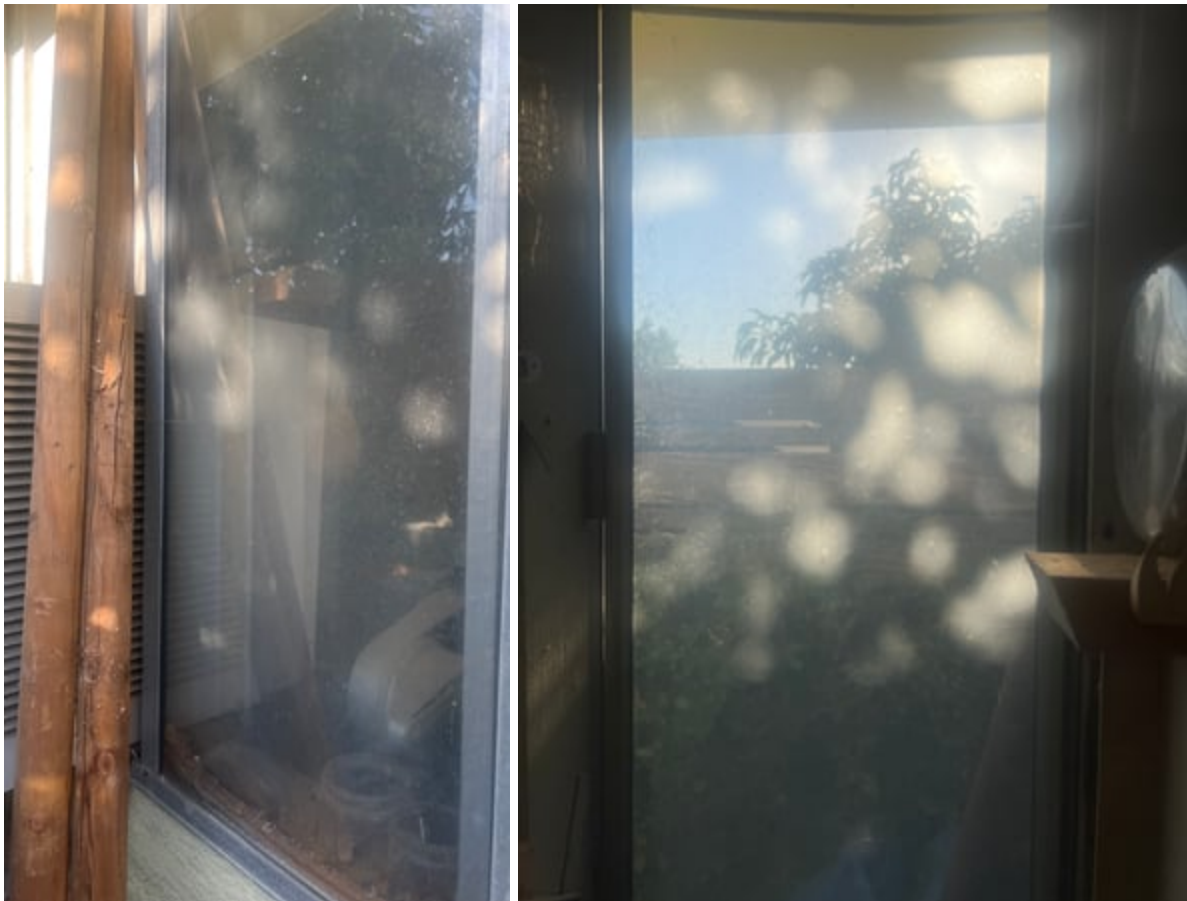
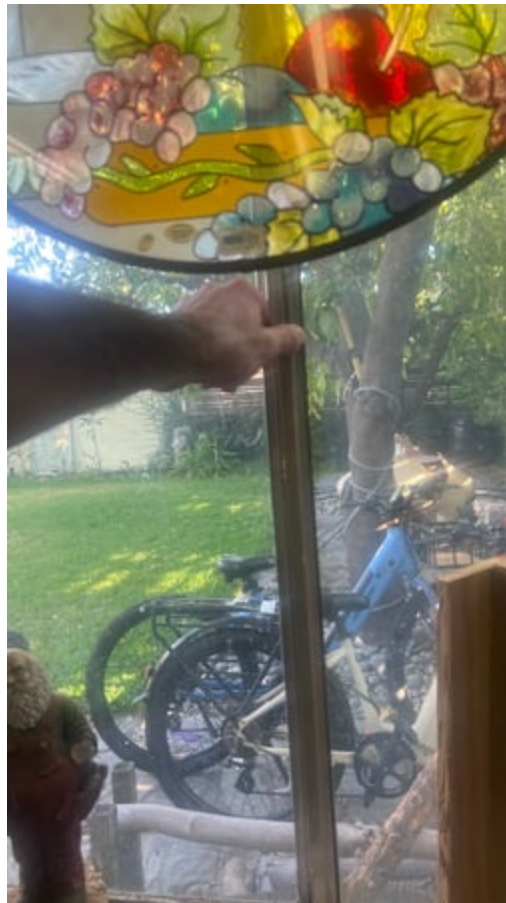
Woodshop windows were observed with failed seals, evidenced by fogging between panes. This condition reduces energy efficiency and visibility and should be corrected by a qualified glazing contractor. Additionally, one window in the garage was inoperable and could not be opened. While this is not a direct safety issue in a garage, the window should be repaired for proper function. If such a condition is found in a sleeping room, it would be considered a major defect due to egress requirements

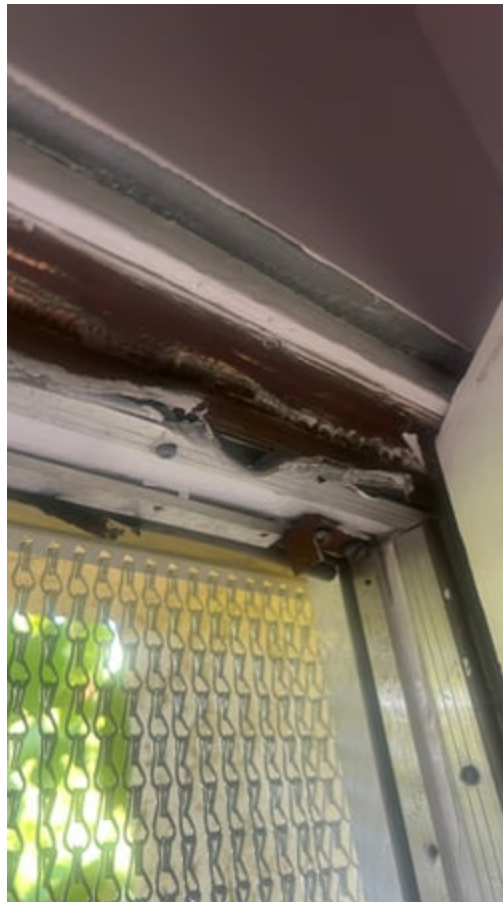
The weatherstripping on the exterior door is warped and no longer providing a proper seal. This may allow air leakage, water intrusion, and pest entry. I recommend replacement of the door gasket/weatherstripping to restore energy efficiency and weather resistance.

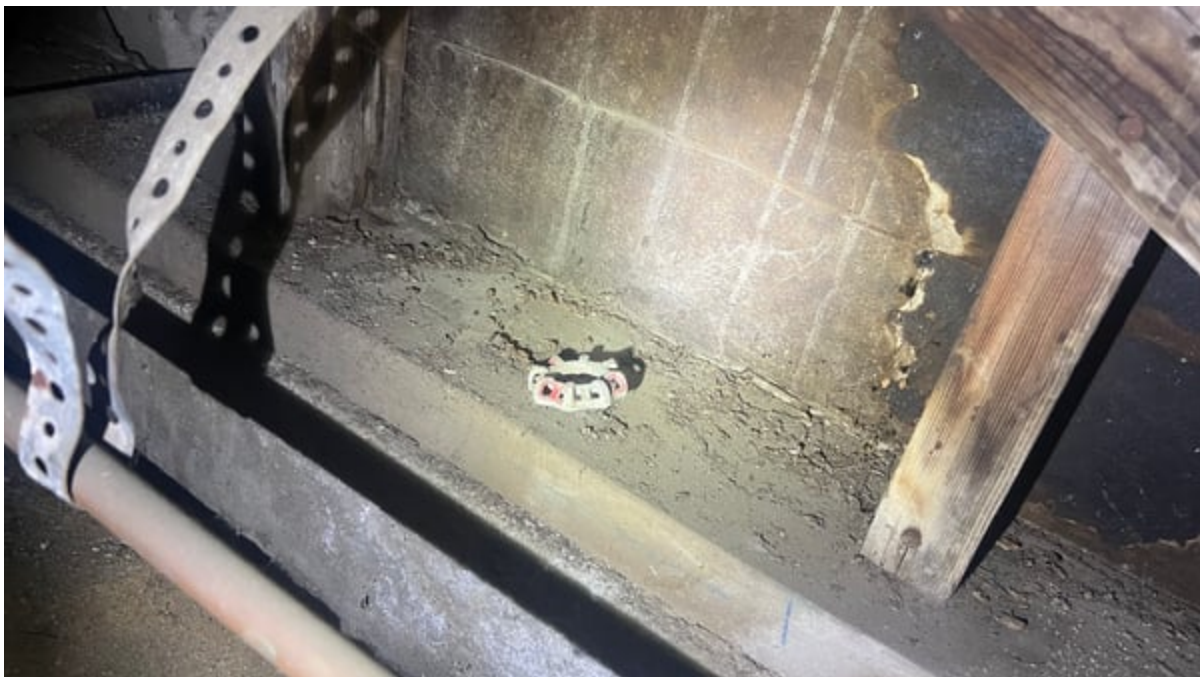
Found a stray valve

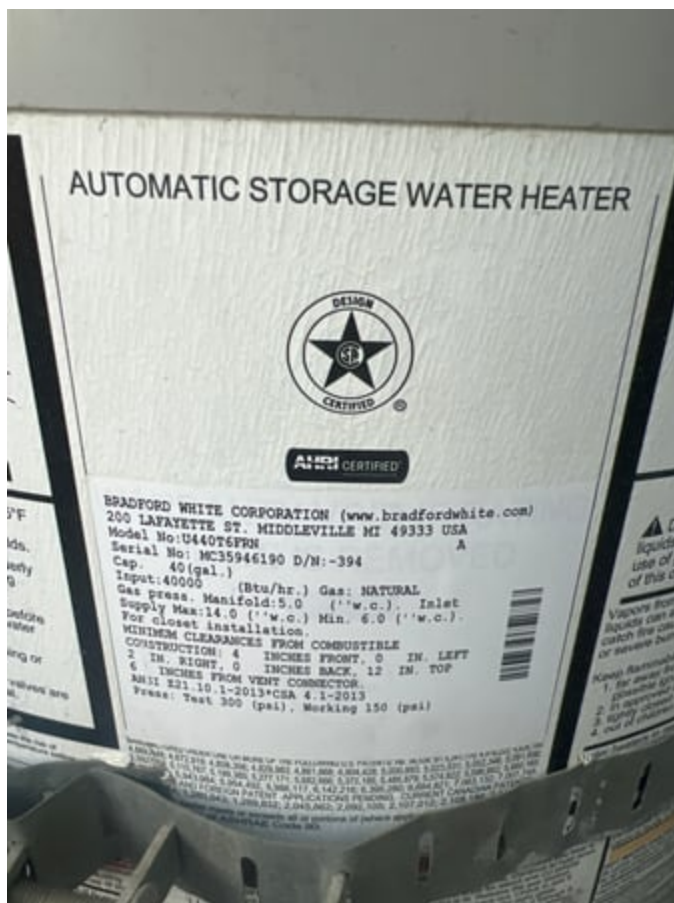
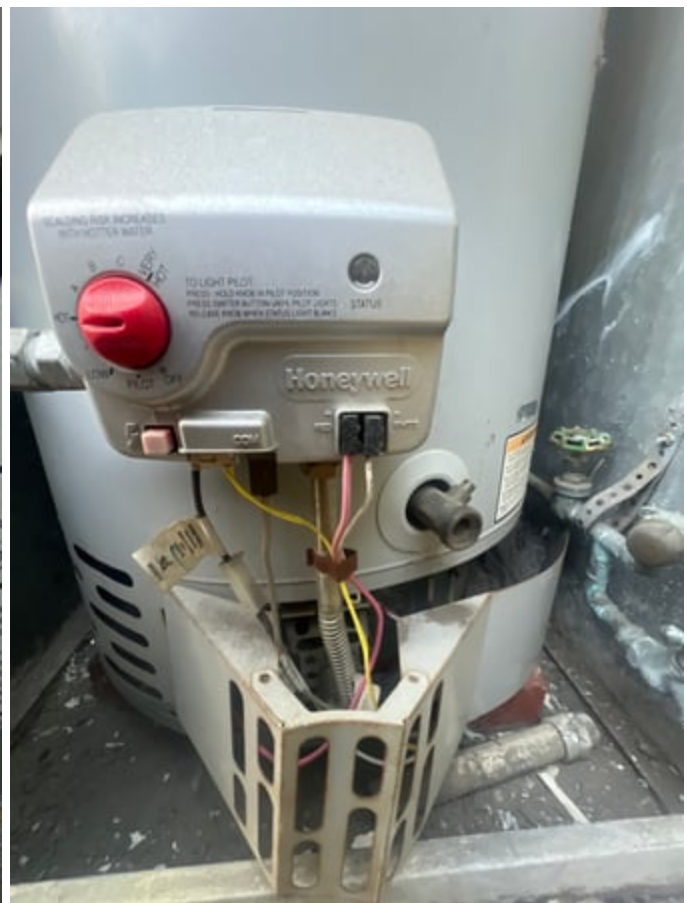
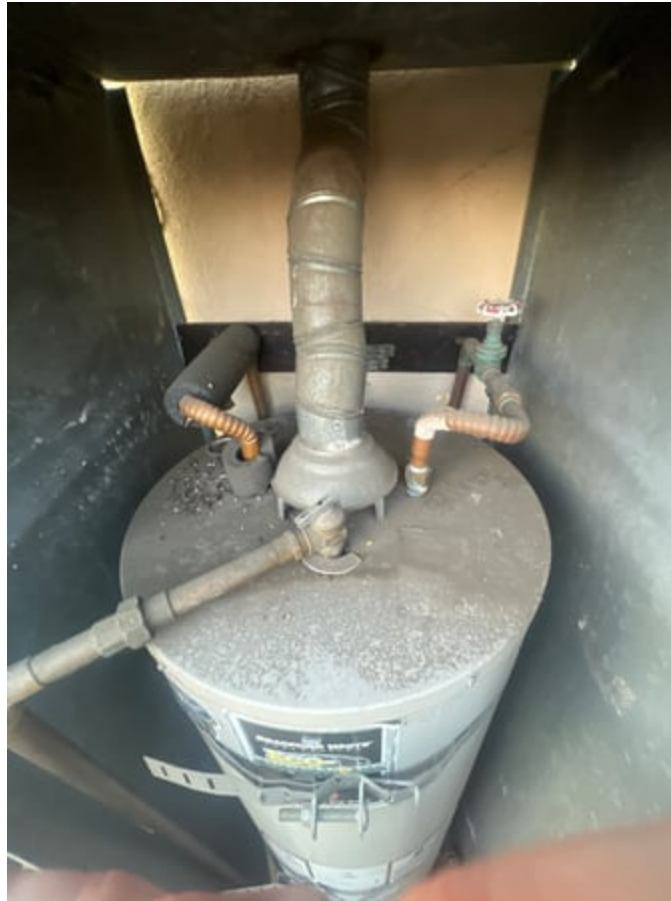
- Type: Bradford White 40-gallon natural gas-fired storage water heater.
- Location: Exterior utility closet.
- Condition: Functional at time of inspection. Vent connector and fittings show age and corrosion consistent with normal wear. No active leaks observed.
- Recommendation: Routine servicing and cleaning recommended. Monitor for future leaks at water and gas connections.

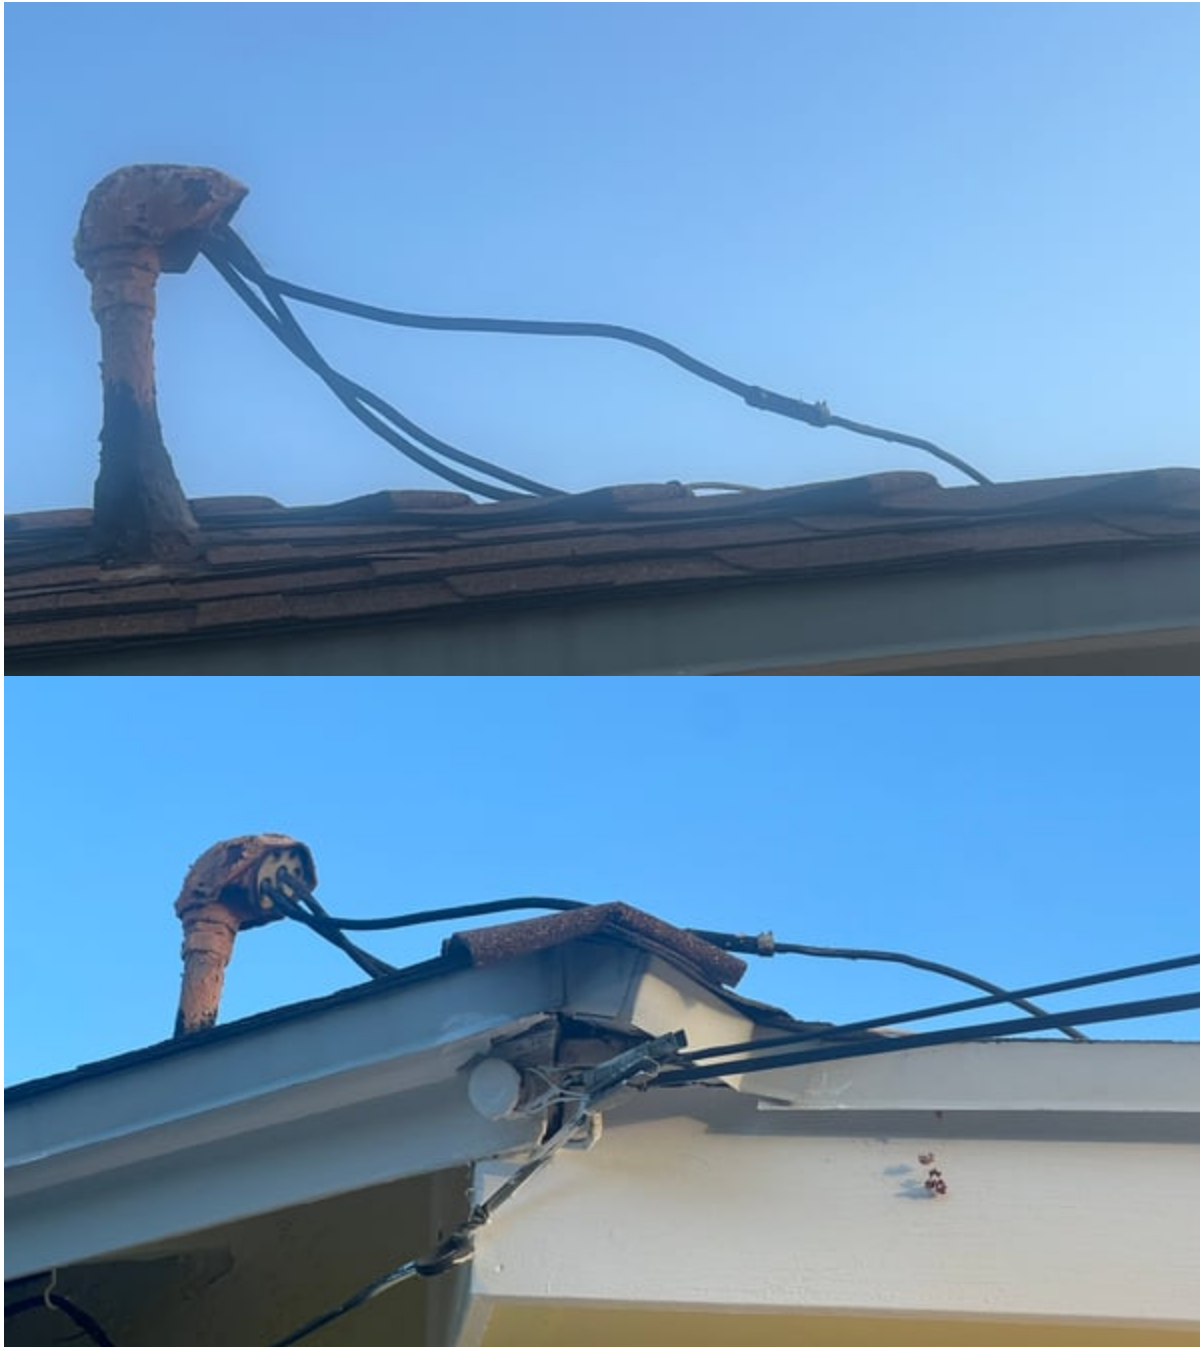
The overhead electrical service drop conductors were observed with exposed splices and insufficient clearance from the roof surface. A licensed electrical contractor should evaluate and make necessary corrections. These repairs are important to reduce risk of electrical shock, fire, and utility service failure.

At the attachment point, the service conductors appear loosely secured, creating potential strain and risk of detachment. Recommendation: A licensed electrical contractor should evaluate and make necessary corrections. These repairs are important to reduce risk of electrical shock, fire, and utility service failure.

The overhead service conductors were observed with exposed splices and deteriorated insulation. The service head (gooseneck) exhibited deterioration and lacked proper drip loops, which may allow moisture intrusion. The service drop attachment appeared inadequately supported. These conditions represent material and major defects due to the potential for electrical shock, fire hazards, and water intrusion. Evaluation and repair by a licensed electrician recommended.

The service mast and conduit were present but the mast head was deteriorated, weather protection was failing, and drip loops were not installed. Recommend: A licensed electrician should evaluate and repair to ensure safe and weather-tight service entry.

The service entrance conductors were observed at the service mast/gooseneck. The conductor insulation appeared weathered and deteriorated in areas, with evidence of exposure. The conductors were in close contact with the roof surface, and no drip loops were observed at the point of entry. These conditions increase the risk of water intrusion and abrasion of the conductor insulation over time. It is recommended that a licensed electrician evaluate the service entrance conductors. Repair or replacement should be performed as needed to restore insulation integrity, proper clearance from the roof, and weather protection. Proper drip loops should also be installed to help prevent water infiltration into the electrical system.

The service-entrance conductors were observed at the roofline. The conductor insulation showed signs of wear and deterioration. The drip loop was either insufficient or absent, which could allow moisture intrusion into the service head. The vertical clearance of the conductors above the roof appeared inadequate and did not seem to meet standard safety clearances.

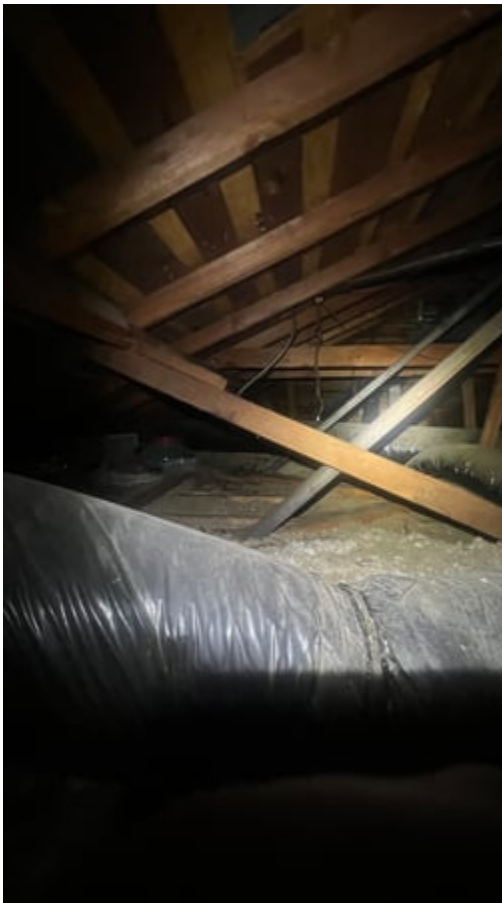
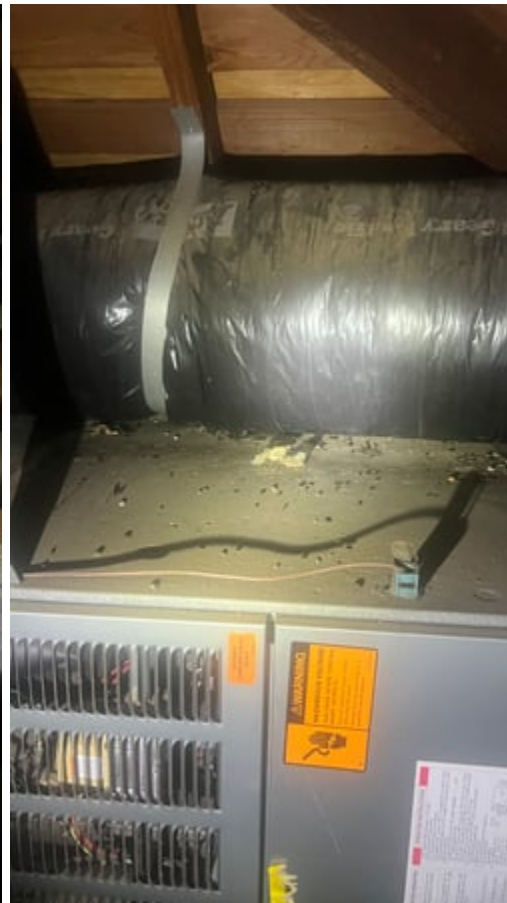
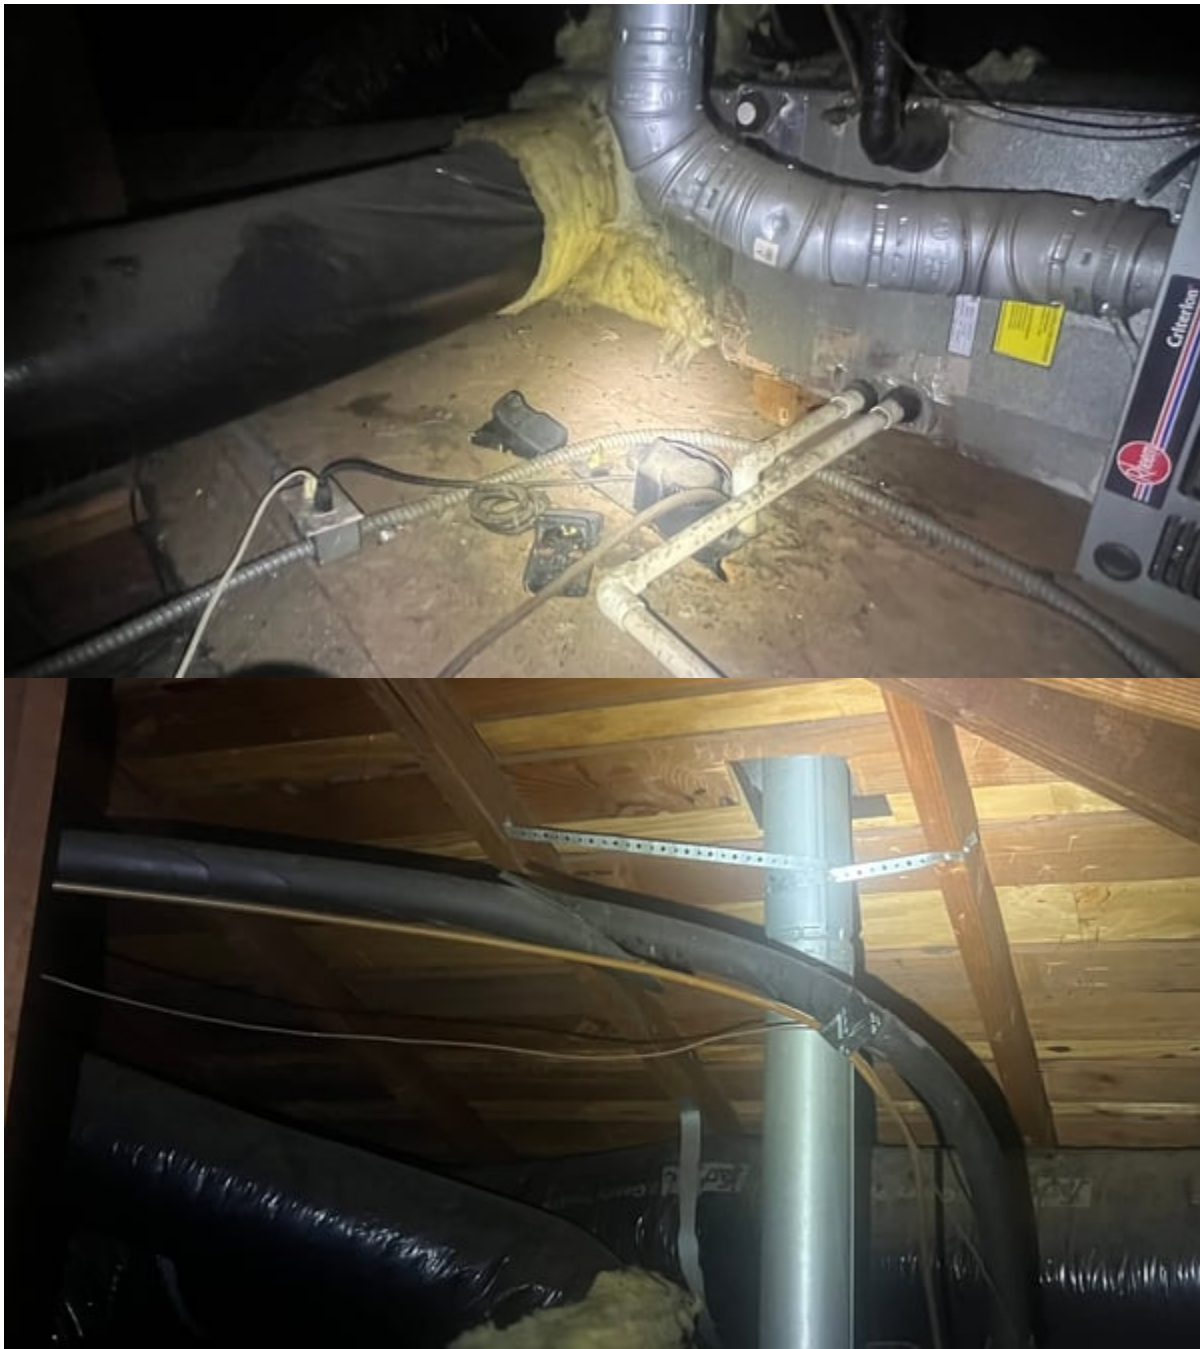
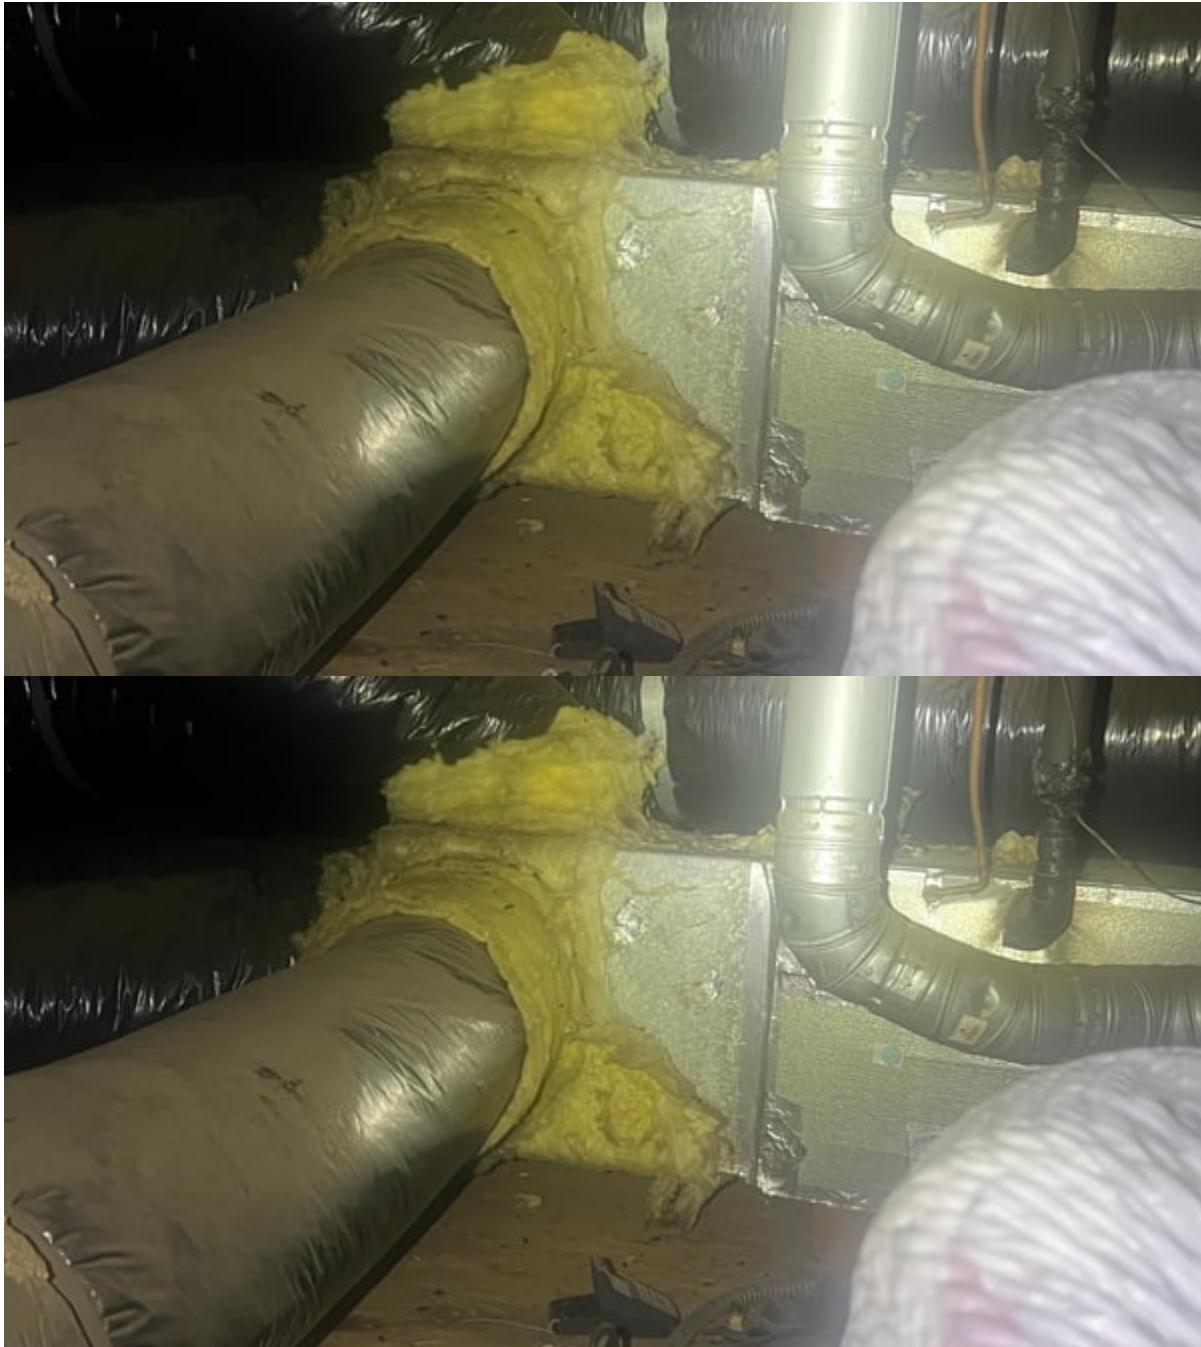
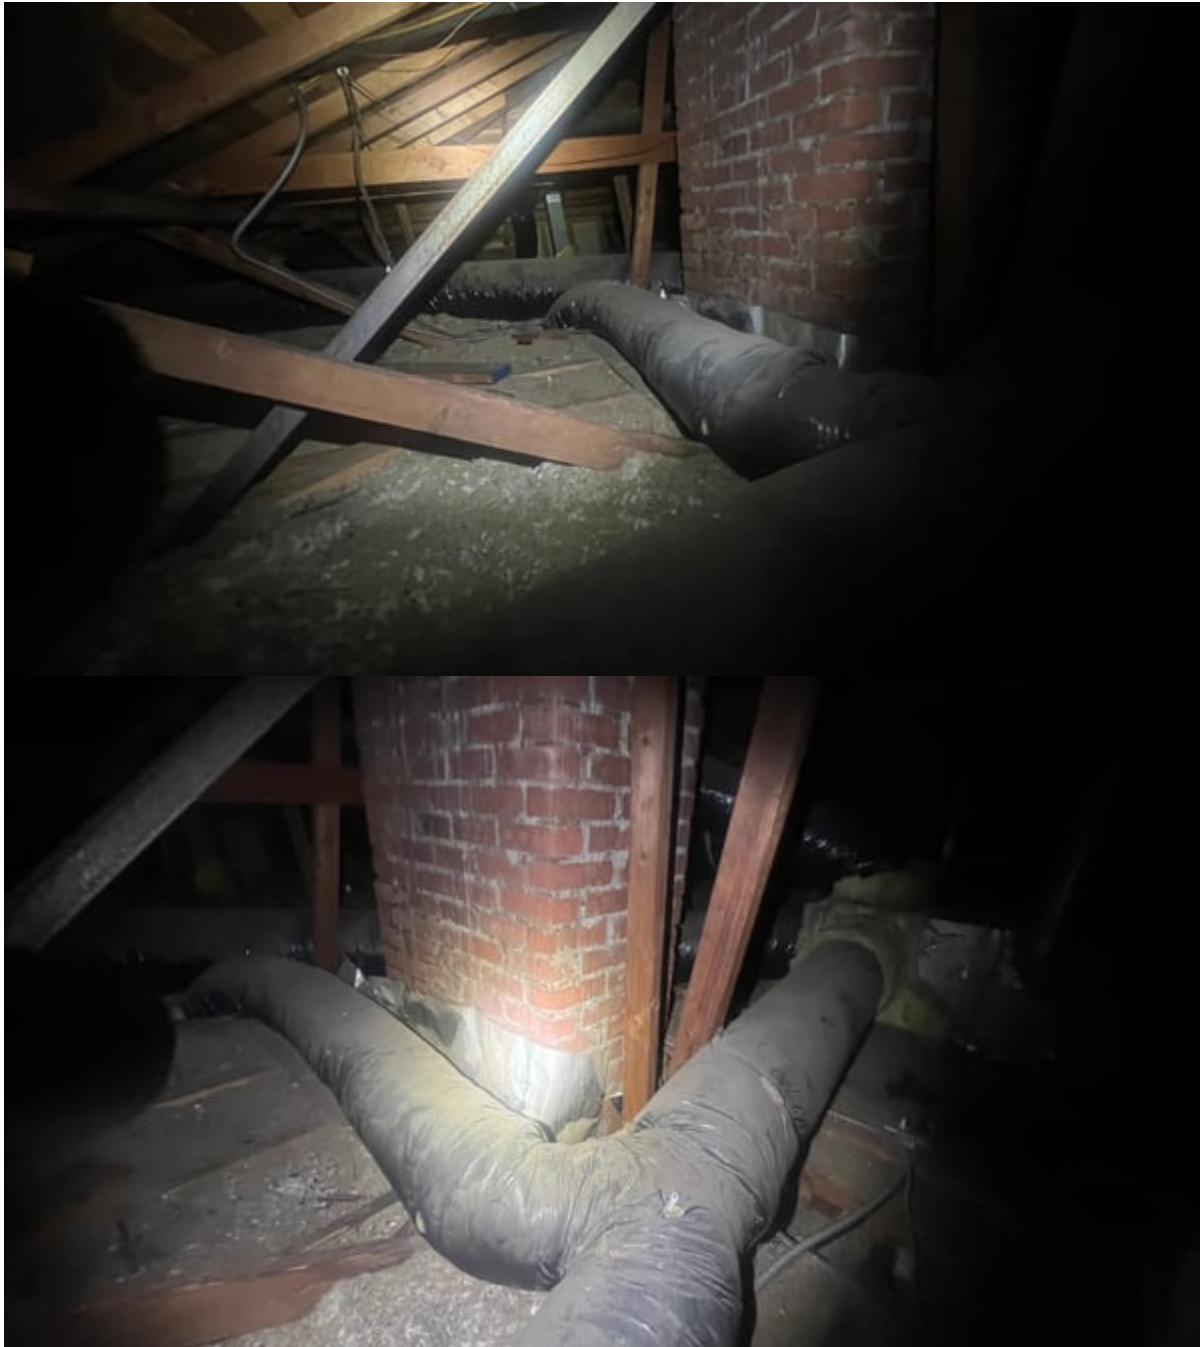
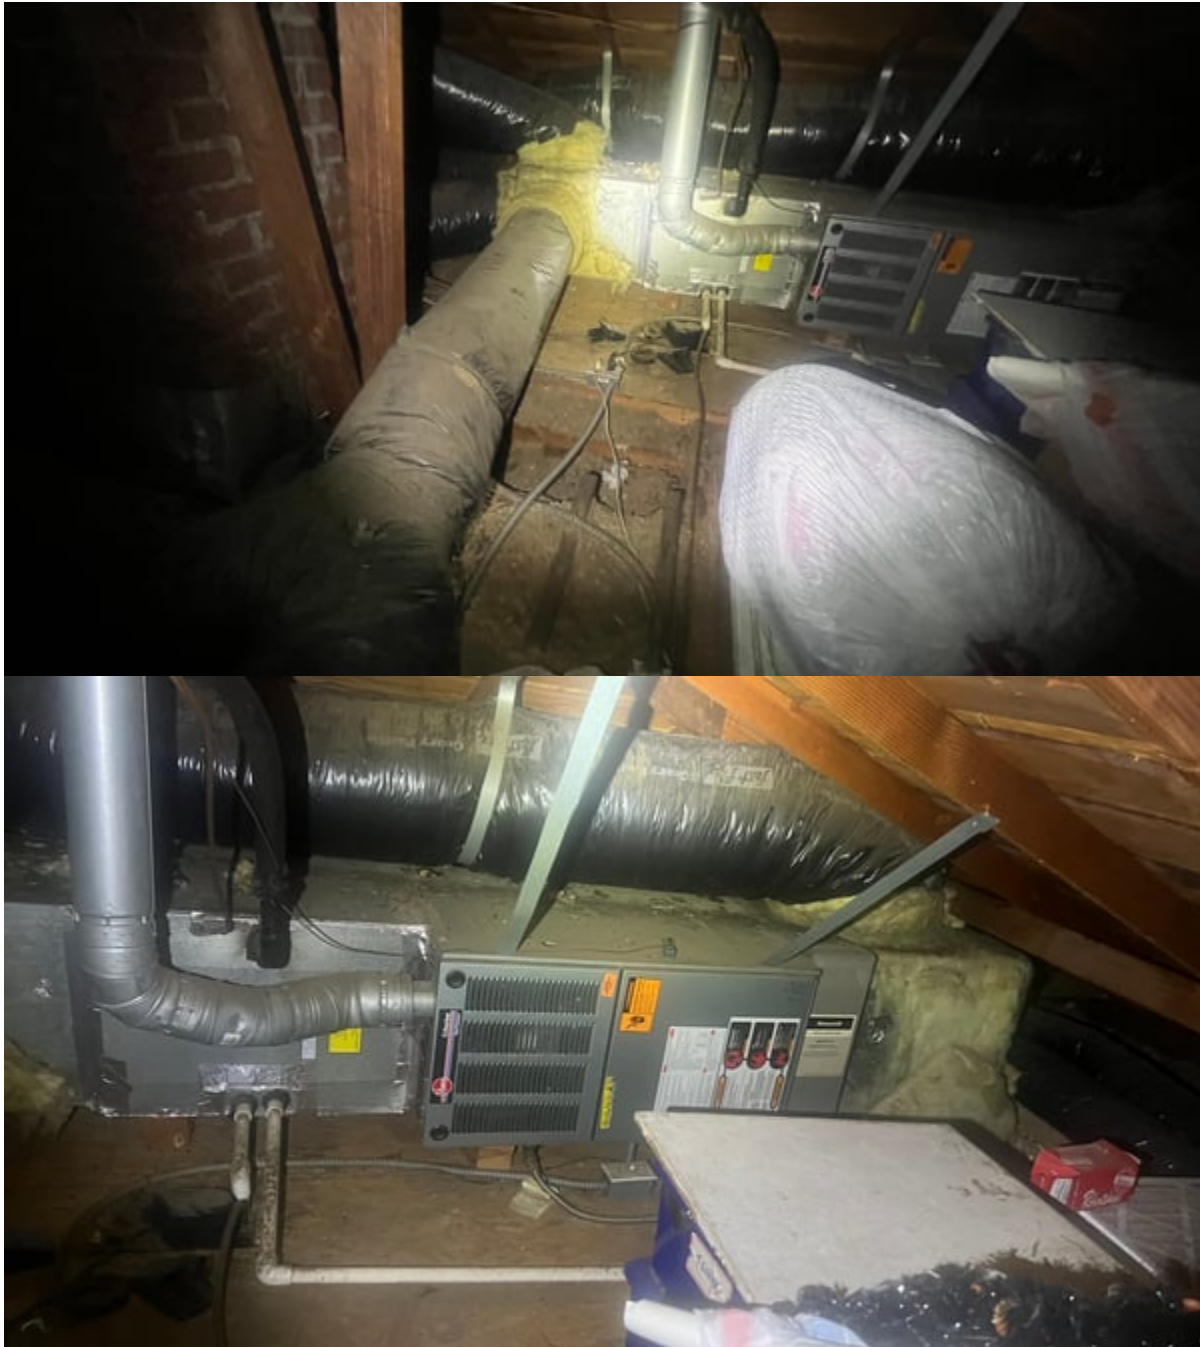
Observed Condition: Rodent droppings were observed on and around the furnace cabinet, indicating possible pest activity. Recommendation: Recommend pest control evaluation and treatment, and cleaning/inspection of the HVAC system by a licensed contractor.

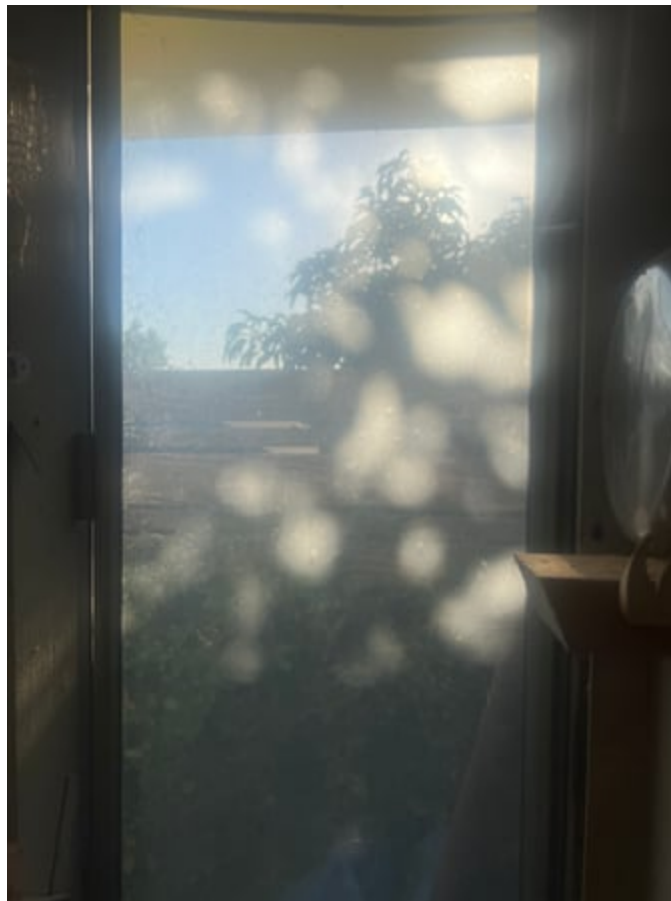
The sliding glass door exhibited a failed insulated glass seal, as evidenced by clouding/fogging between panes. Recommendation: Recommend repair or replacement by a qualified window/door contractor.
